# THE DEAD MAC SCROLLS

HOW TO FIX HUNDREDS OF HARDWARE PROBLEMS WITHOUT GOING BANKRUPT

## LARRY PINA

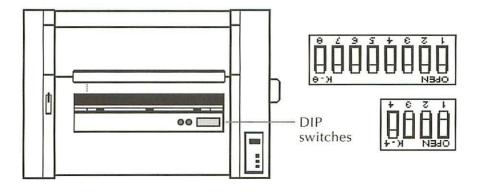
**Probable diagnosis:** The DIP switches are incorrectly set for allaround Mac use.

**Solution:** Position the DIP switches inside the ImageWriter exactly as shown. If that doesn't do it, see the next entry.

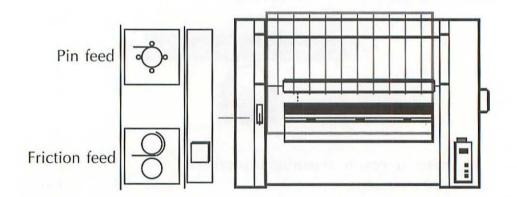
**Probable diagnosis:** The release lever is positioned for friction-feed paper (not pin-feed).

Solution: Push the release lever toward the pin-feed icon.

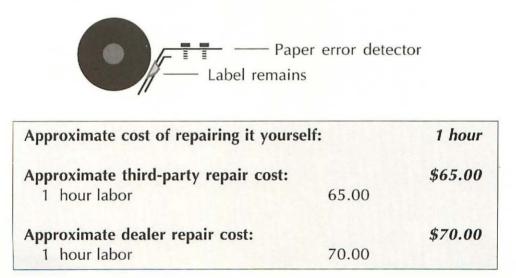
**Symptoms:** Printing doesn't stop when the paper runs out. Instead, it continues right across the platen.

**Probable diagnosis:** The paper error detector is malfunctioning. Most likely, a mailing label got stuck under the platen and the detector arm is jammed by a piece that's still in there.

**Solution:** Remove the platen. Clear the stuck mailing label. Check/reposition the paper error detector.

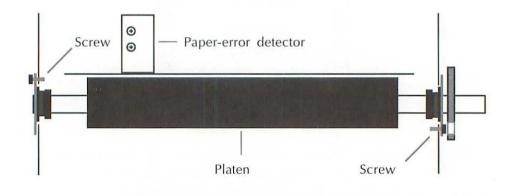
**Symptoms:** It's hard to load paper. Something seems to be blocking the paper path.

**Probable diagnosis:** Most likely, a mailing label is or was stuck under the platen and/or the arm on the paper-error detector is bent.

**Solution:** Remove the platen. Clear the label jam. Check/reposition the paper-error detector.

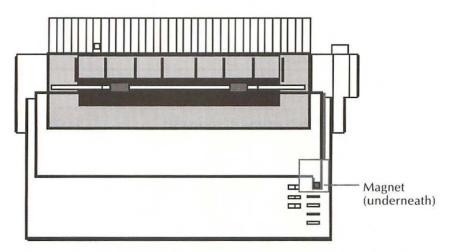
**Probable diagnosis:** The front cover is incorrectly positioned, or the safety magnet (underneath the front cover) is missing.

**Solution:** Check/reposition the front cover. Check the safety magnet. Verify the operation of the reed switch (normally activated by the front cover magnet) with a small crafts magnet. If everything under the front cover checks OK, see the next entry.

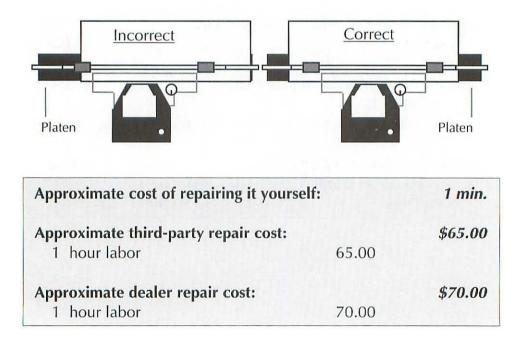
**Probable diagnosis:** The paper is too far to the right. It's not being detected by the paper error sensor, which is located on the left side of the platen.

Solution: Move the paper to the left. Center it on the platen.

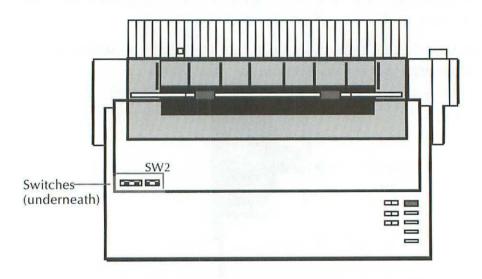
Probable diagnosis: The character deviation is out of adjustment.

**Solution:** Adjust DIP switches SW2-5 and SW2-6 (located under the front cover) for best linearity. Also see the next entry.

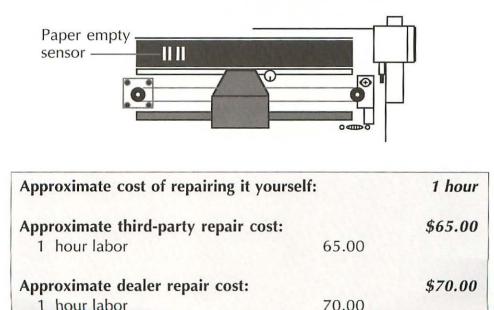
**Probable diagnosis:** The paper empty sensor is malfunctioning. Most likely, a mailing label is stuck under the platen.

Solution: Remove the platen. Clear the stuck mailing label.

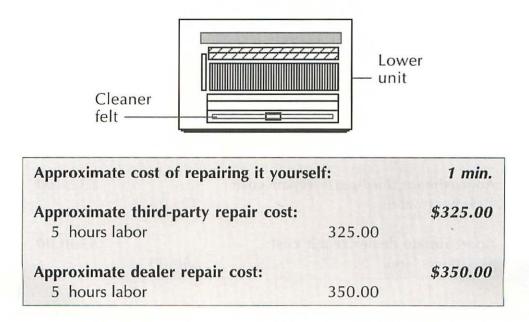
Probable diagnosis: The fuser roller cleaner felt is worn.

**Solution:** Check/replace the fuser roller cleaner felt (HP part FG1-2377-020). If that doesn't do it, see the next entry.

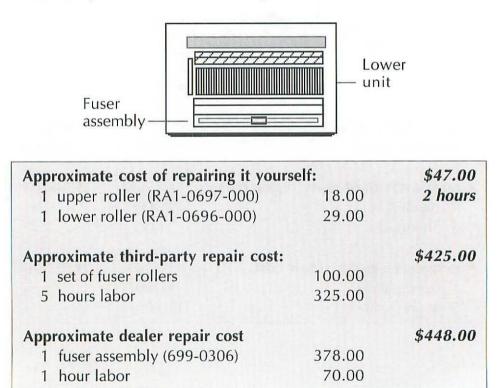
Probable diagnosis: The fuser rollers are clogged with toner.

**Solution:** Check/replace the toner cartridge (HP part 92285A), clean the lower unit and clean/replace the upper and lower fuser rollers (HP part RA1-0697-000, HP part RA1-0696-000).

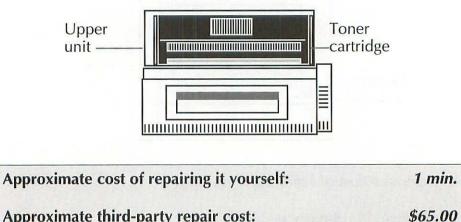
Probable diagnosis: The sealing tape is still in the toner cartridge.

**Solution:** Check/remove the factory sealing tape.

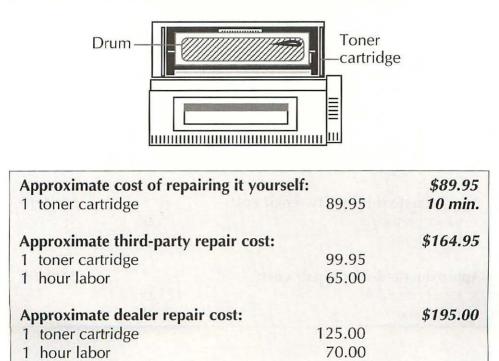
Probable diagnosis: The photosensitive drum needs cleaning.

**Solution:** Clean the affected edge of the photosensitive drum. If the problem recurs, replace the toner cartridge (HP part 92295A).
